WHY IS FITTING CORROSION SUCH A BIG PROBLEM?

E-Coat 1000 - Over 1,000 hours of corrosion protection

Best-In-Class Corrosion Resistance - Putting it to the test

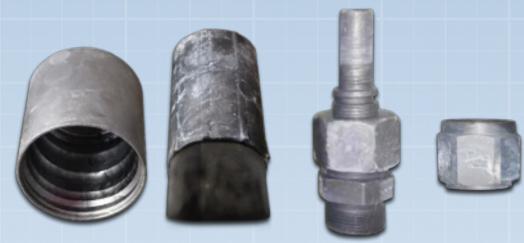
E-Coat 1000 after 1,000 hours ASTM B117 (ISO 9227) salt spray test

Competitor A after 1,000 hours ASTM B117 (ISO 9227) salt spray test

Competitor B after 1,000 hours ASTM B117 (ISO 9227) salt spray test

Many other fitting manufacturers declare the superb corrosion resistance of their fittings, so we test against the best of the competition. The results speak for themselves. The best comparable comboth declare 1,000 hours to red rust, however, they both began to show red corrosion after less and were seriously corroded by 750 hours. In contrast, the Manuli sample with E-Coat 1000 was signs of white corrosion after more than 1,000 hours in salt spray conditions. Even crimped fitting 1000 lasted over 750 hours before showing significant signs of corrosion, despite the damage integrity which occurs during the mechanical deformation process of crimping.
